**DEPARTMENT OF TRANSPORTATION**

Contract #: 04-0120F4Cty: SF/ALA Rte: 80 PM: 13.2/13.9File #: 69.28**WELDING INSPECTION REPORT****Resident Engineer:**Siegenthaler, Peter**Address:** 333 Burma Road**City:** Oakland, CA 94607**Report No:** WIR-017443**Date Inspected:** 02-Oct-2010**Project Name:** SAS Superstructure**OSM Arrival Time:** 700**Prime Contractor:** American Bridge/Fluor Enterprises, a JV**OSM Departure Time:** 1900**Contractor:** Zhenhua Port Machinery Company, Ltd (ZPMC), Changxing Island **Location:** Shanghai, China**CWI Name:** Xu Le Feng**CWI Present:** Yes No**Inspected CWI report:** Yes No N/A**Rod Oven in Use:** Yes No N/A**Electrode to specification:** Yes No N/A**Weld Procedures Followed:** Yes No N/A**Qualified Welders:** Yes No N/A**Verified Joint Fit-up:** Yes No N/A**Approved Drawings:** Yes No N/A**Approved WPS:** Yes No N/A**Delayed / Cancelled:** Yes No N/A**Bridge No:** 34-0006**Component:** Tower & OBG Components**Summary of Items Observed:**

#### ORTHOTROPIC BOX GIRDER (OBG) AT BAY#11

#### ORTHOTROPIC BOX GIRDER (OBG) AT BAY#12

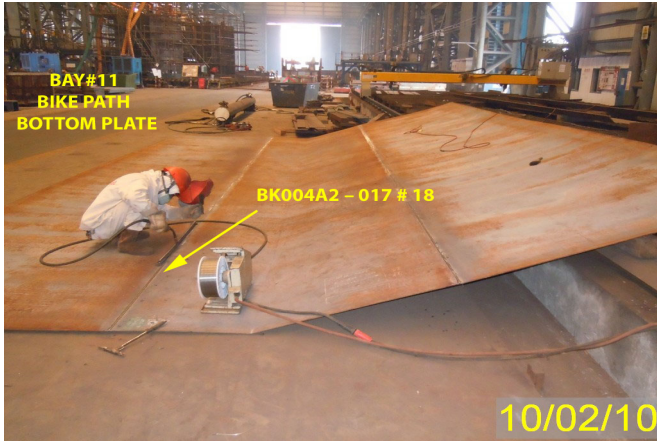
Weld joint # 18 located on Bike Path bottom plate BK004A2 – 017. Welder is identified as 067138. ZPMC Quality Control (QC) Inspector is identified as Shang Hai Long. The welding variables recorded by QC appeared to comply with the WPS – B – T – 2231 – B – L1b – F – 1. (See attached photo)

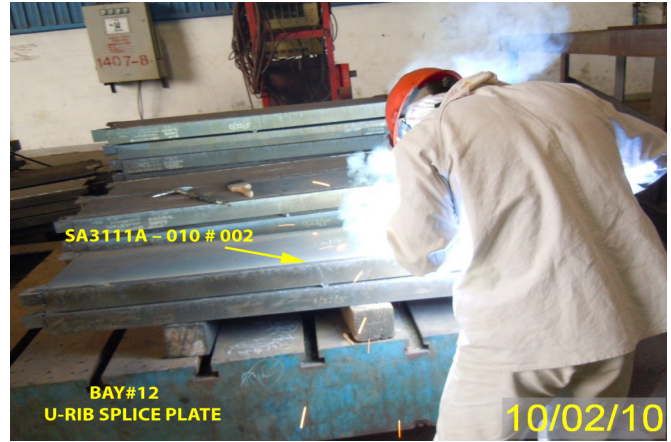
Weld joint # 02 located on U-rib splice plate SA3111A – 010. Welder is identified as 059403. ZPMC Quality Control (QC) Inspector is identified as Zhao Jian Hang. The welding variables recorded by QC appeared to comply with the WPS – B – T – 2231 – Tc – U4b – F. (See attached photo)
